Manhole Inspection Summary

Manhole # S15E1_010MH

Insp Date: **5/28/08 8:20 AM**

Location Address: **3100 washington bd**

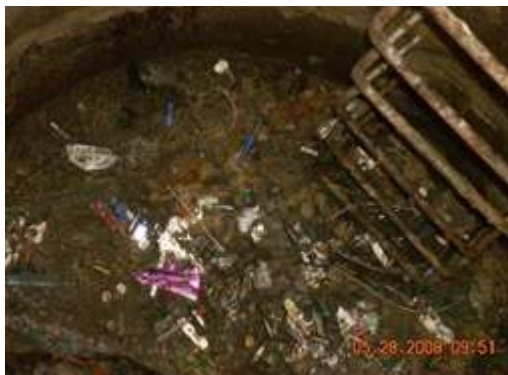
Defect 4

Condition: ☐ Sound ☐ Cracked ☐ Root Intrusion ☐ Deteriorated ☐ Leaks ☒ **Debris**

debris on bench

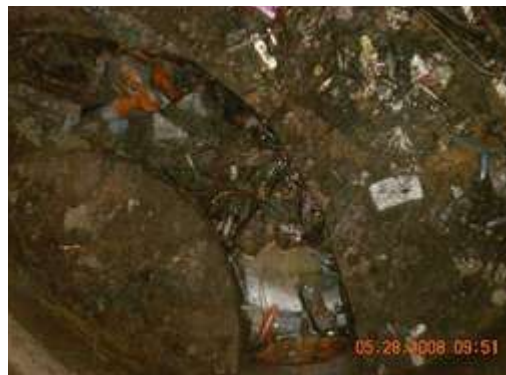
Defect 3

Condition: ☐ Sound ☐ Cracked ☐ Root Intrusion ☐ Deteriorated ☐ Leaks ☒ **Debris**

debris in channel

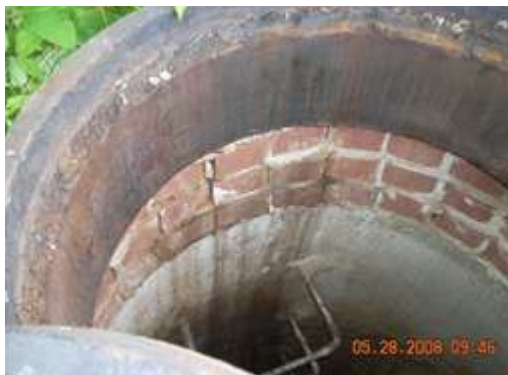
Defect 2

Infiltration: ☐ None ☒ **Joint** ☐ Cracks ☐ Mortar ☐ Roots ☐ Wall

infiltration @ chimney/frame joint

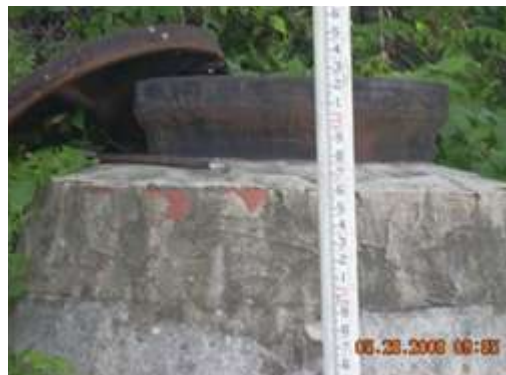
Defect 1

corbel/frame above grade

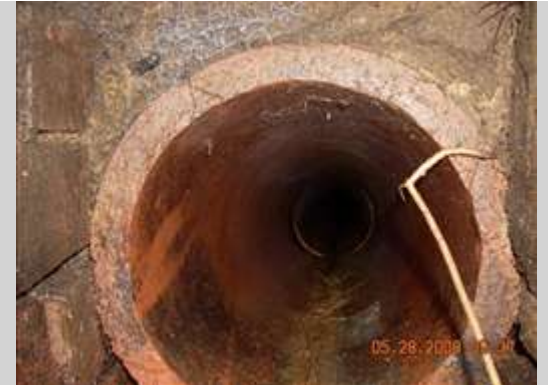
12 O'Clock Outflow

Infiltration: **None** Pipe Seal Cond: **Roots**

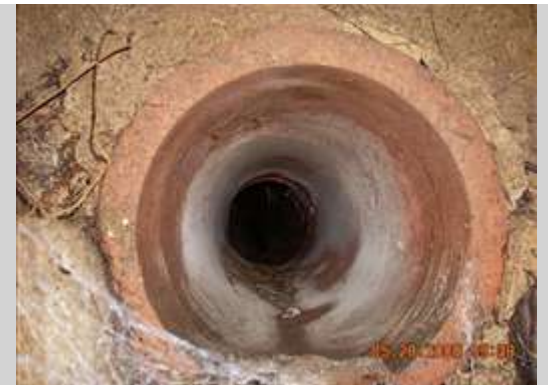
3 O'Clock Inflow

roots around and inside pipe

Infiltration: **None** Pipe Seal Cond: **Roots**
